**NASA TM X-2785**

**A 13 000-HOUR TEST OF  
A MERCURY HOLLOW CATHODE**

*by Vincent K. Rawlin*

*Lewis Research Center*

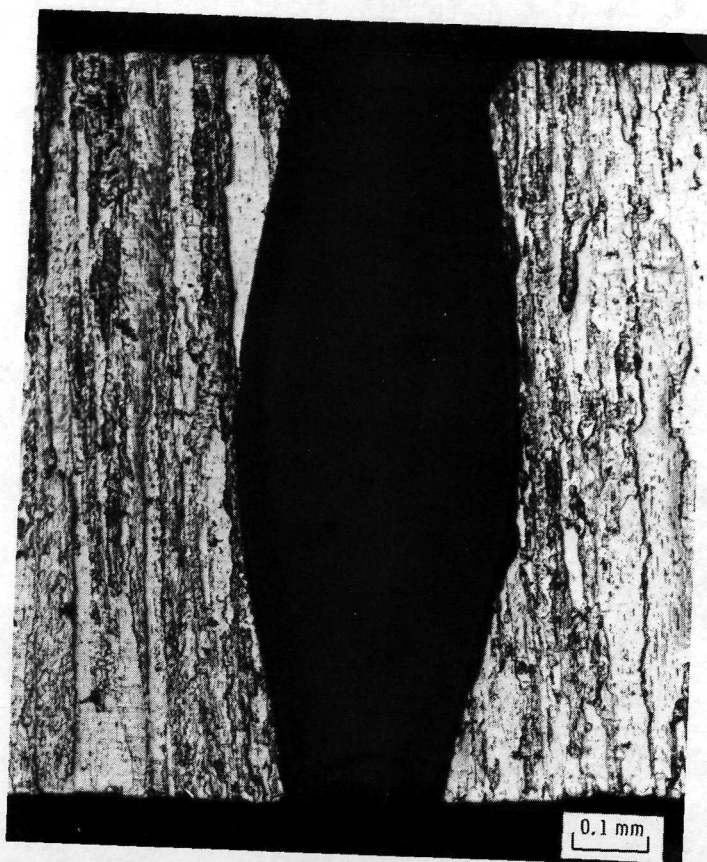
Figure 5. - Cross-sectioned cathode tips.

(a) Unused cathode.

(b) Endurance-tested cathode.

Cathode orifice dimensions. - Figure 3 showed how the orifice dimensions varied over the test period. Figure 5(a) is a 100-power photomicrograph of a cross-sectioned unused cathode orifice. The orifice shape is typical of those used in the SERT II program and in this 13 000-hour test. As stated in the APPARATUS section, the contoured orifice was made with an abrasive sandblaster. This process always resulted in a hole which was larger in diameter inside the bulk of the cathode tip than at either end. The maximum diameter of about 0.4 millimeter was located about one-third of the tip thickness from the downstream face of the cathode tip. Note that if the downstream face of the cathode tip were worn away, the downstream orifice diameter would naturally increase until the maximum diameter of the orifice was reached. Figure 5(b) is a 100-power photomicrograph of the cross-sectioned 13 000-hour test cathode. The surface shown is displaced approximately 0.03 millimeter from the cathode orifice axis, which makes the diameters measured from this photomicrograph slightly smaller than those listed in table I. Figure 5(b) shows that the downstream face of the cathode was worn away, thereby reducing the orifice length.

Figure 5(b) also shows a thin layer of small-grain tungsten along most of the orifice

length, which accounts for the decrease in the upstream orifice diameter observed during the test. The large elongated grains which make up the bulk of the cathode tips shown in figure 5 are typical of the original condition of the cathode material. Inspection of the cross-sectioned cathode tip with an electron scanning microscope indicated that no thoria was present in the region of the small grains. The small-grained layer was, therefore, not the same as the parent tip material. Since there was a direct line of sight from the downstream edge of the orifice to the upstream region of the orifice, it is probable that some of the sputtered tungsten atoms condensed on the orifice walls. As the orifice length decreased because of ion bombardment, the condensed tungsten layer as well as the parent tip material would be removed, as shown in figure 5(b). Deposition of sputtered cathode material has been observed in other long-term tests with cathodes of this type. The endurance test of the 5-centimeter ion thruster reported in reference 10 was recently terminated at 9700 hours. Erosion of the hollow-cathode neutralizer used in that test was similar to that reported herein for the 13 000-hour cathode. Condensed tungsten, free of thoria, was found on the upstream side of the enclosed keeper cap. (Information obtained through private communication with Wayne R. Hudson of the NASA Lewis Research Center.)
